INTERIM PROJECT REPORT
NO. MS PR 61-45

CONTRACT NO. DA-04-200-507-ORD-333
UNDER ARMY PROJECT NOS. 593-32-003 AND 593-32-005
PHASE REPORT NO. 9
EFFECT OF CONTROLLED WELD DEFECTS ON THE BALLISTIC
PERFORMANCE OF 5083 ALUMINUM ALLOY WELDMENTS

M. B. Kasen

DEPARTMENT OF METALLURGICAL RESEARCH

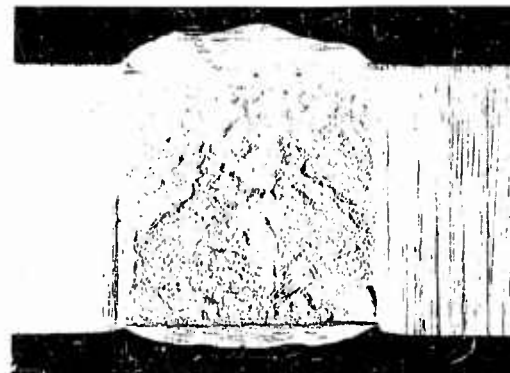
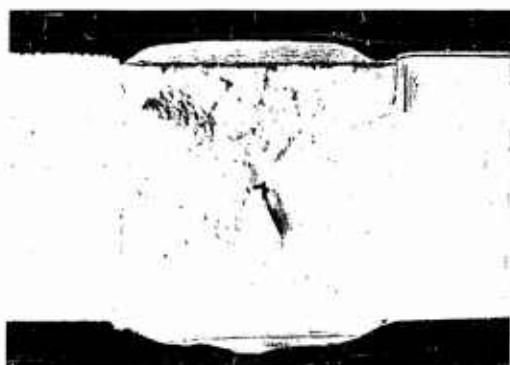
Figure 8
RESULTS OF RADIOGRAPHIC AND FRACTURE EXAMINATION OF WELDS CONTAINING
VARIOUS QUANTITIES OF DROSS FILMS

(a)
Conventional Radiograph
(T) = Location of transverse fracture
(L) = Length of weld included in
longitudinal fracture

(b)
Longitudinal Fracture

(c)
Transverse Fracture

To confirm this limitation of radiographic examinations, a supplemental study was conducted. Weldments containing dross films in four degrees of severity were produced. These different dross levels were obtained by using arc voltages of 24, 25, 26 and 27 volts, respectively. Each weldment was radiographed after completion. Then, the welds were examined further by making fracture tests both longitudinal and transverse to the welding direction. The results of the study are shown in Figure 8. Both the longitudinal and transverse weld fractures clearly show the presence of severe amounts of dross films in the welds made with longer arcs and higher voltages, whereas the radiographs fail completely to reveal these defects.

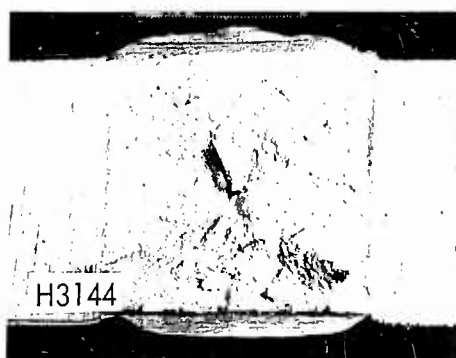
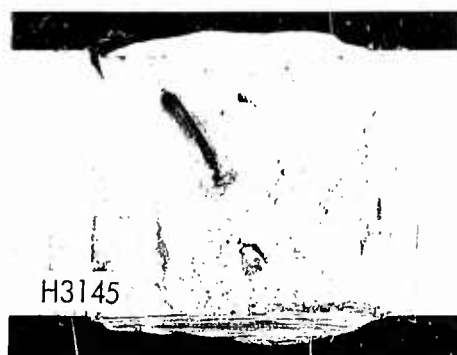
Figure 11

(a) Control Weld (No Defects)

(b) Moderate Dross Films

(c) Severe Dross Films

A correlation was also found between the severity of the cross film defect and the ultrasonic indication of this defect (Figure 11).

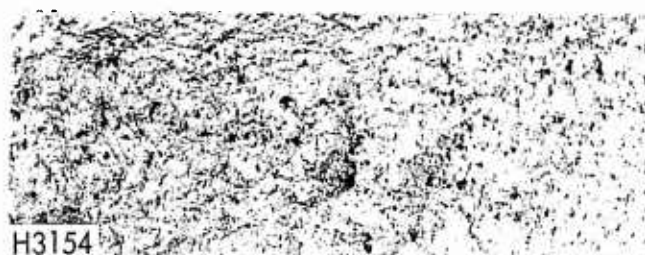
(a) Control Weld (No Defects)

(b) Moderate Fine Dross

(c) Severe Fine Dross

The ultrasonic traces obtained from welds containing scattered fine cross gave indications of the presence of this defect, but did not provide sufficient differences in indications to discriminate between the different defect severities (Figure 12).

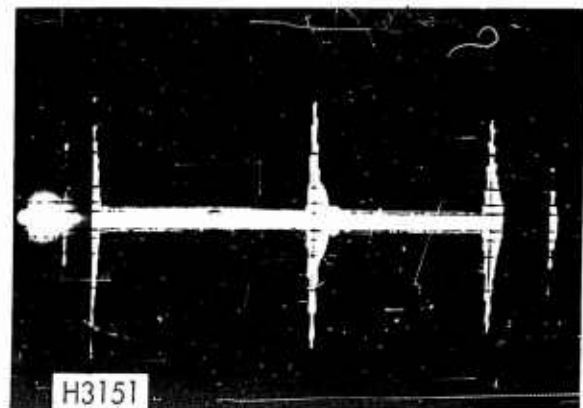
Figure 13
LACK OF ROOT FUSION SERIES
Extent of Weld Defect as Determined From Transverse Macrosection and Ultrasonic Examinations

(b) Moderate Lack of Fusion

(c) Severe Lack of Fusion

For the weldments containing lack of root fusion (Figure 13), a weaker ultrasonic defect indication was obtained from the weld which contained "severe" lack of root fusion than from the weld which contained this defect in "moderate" degree. The defect indication from the "severe" lack of root fusion appeared to be anomalously low. A possible explanation for this anomaly may be that shrinkage contraction of the filler metal in this particular weldment forced the unpenetrated root faces into sufficiently excellent mechanical contact that the ultrasonic beam could, to some extent, be propagated across the unfused mating root faces and thus exhibit less reflection from this defect than if an actual air gap had existed between the unpenetrated root surfaces.

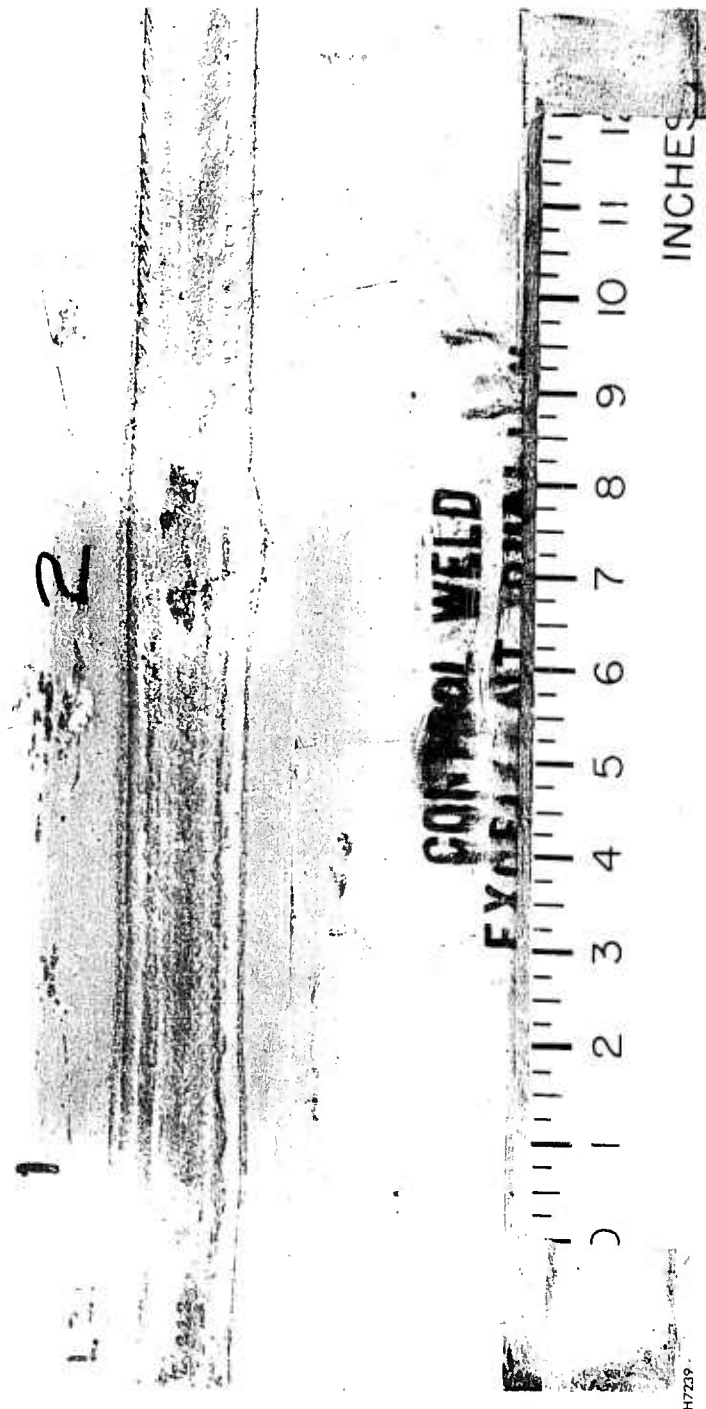
Figure 14
BACK SURFACE OF CONTROL WELDMENT L212 AFTER BALLISTIC SHOCK TEST
This weldment contained no weld defects

It is probably significant that all weldments containing defects showed more extensive cracking than the high-quality control weldment (no weld defects) in the ballistic shock test. This indicates that weld defects have at least some adverse effect upon the ballistic performance of weldments. However, it is important to note that even the worst weld defects did not lead to brittle catastrophic failure of the aluminum weldments. Moreover, the most severe damage encountered was still of a highly localized character, and not of alarming magnitude.

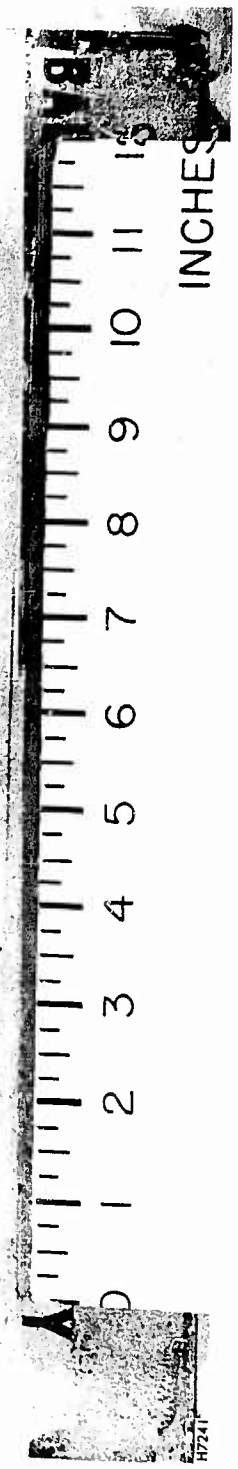
Figure 16
BACK SURFACE OF WELDMENT L223 AFTER BALLISTIC SHOCK TEST
This weldment contained moderate lack of fusion

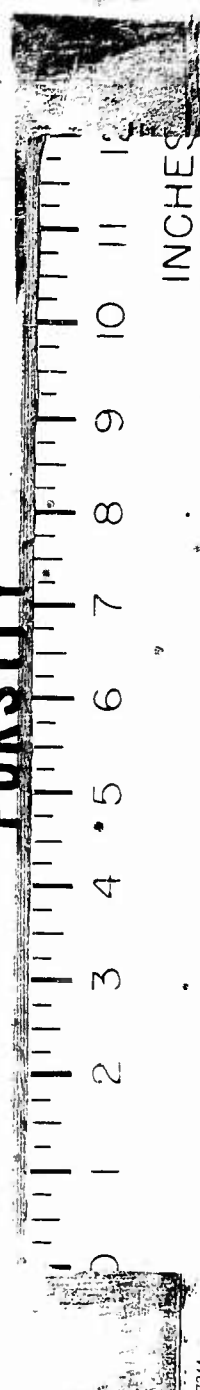
Figure 19

L235

Weld Defect	Weldment No.			
	L212	L240	L235	L229
	None	Porosity, Moderate	Porosity, Severe	Scattered Dross Moderate
Type of Cracks:				
Longitudinal	X	X	X	X
Transverse		X	X	X
Random		X		X
Straight	X	X	X	
Branching		X	X	X
Location of Cracks:				
Fusion Line	X	X		X
Between Beads	X	X	X	X
Random Plate		X	X	
Severity of Cracking:				
No. of large cracks	2	3	2	4
No. of small cracks	4	40	8	20
Dimension of largest cracks,				
Width	3/16	3/16	3/16	1/32
Length	1-3/4	1-3/4	2	1-1/2
Location of largest cracks	Fusion line; between beads	Between beads	Longitudinal with large transverse branches	Transverse
Estimated Order of Increasing Ballistic Damage	1	7	6	4

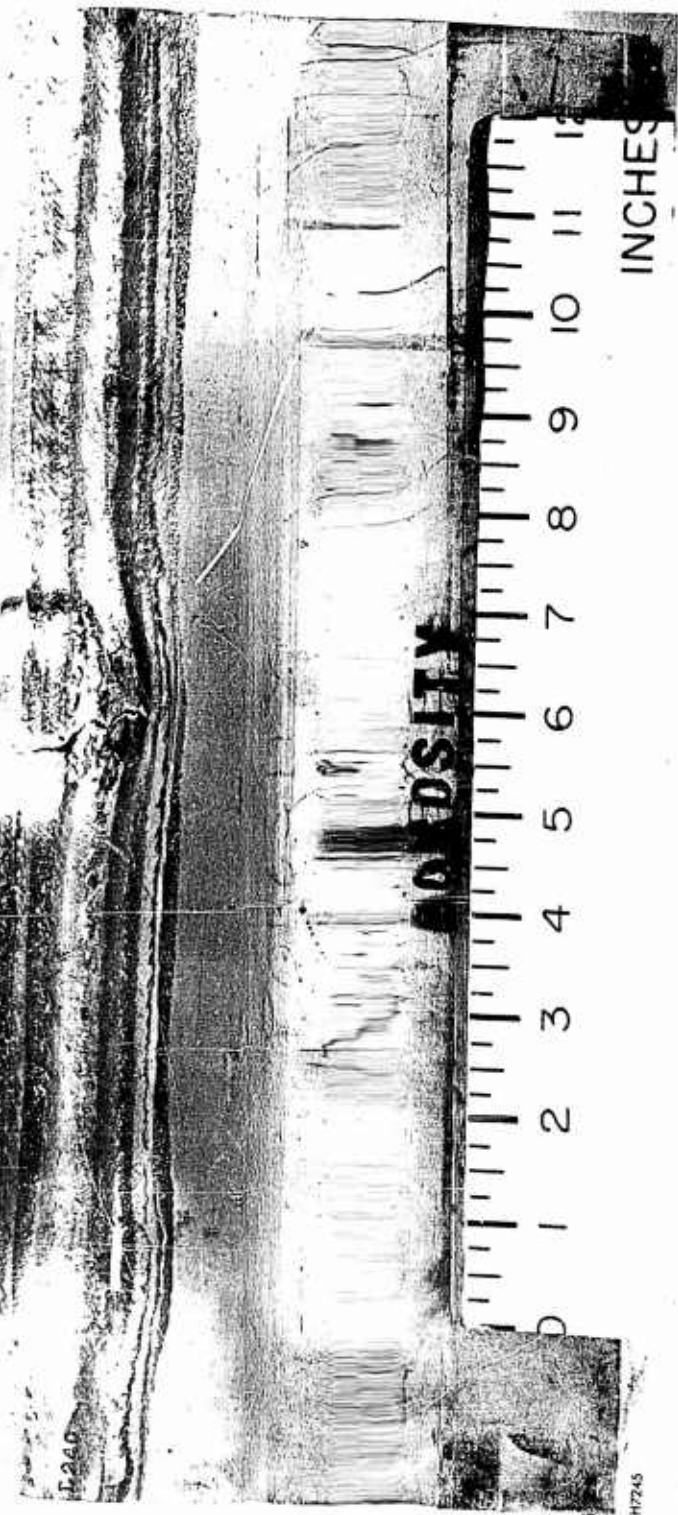
Figure 20
BACK SURFACE OF WELDMENT L240 AFTER BALLISTIC SHOCK TEST
This weldment contained moderate porosity

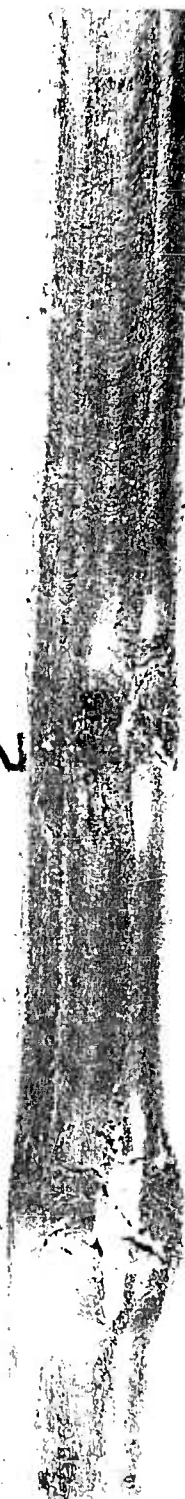
Figure 21

BACK SURFACE OF WELDMENT L226 AFTER BALLISTIC SHOCK TEST

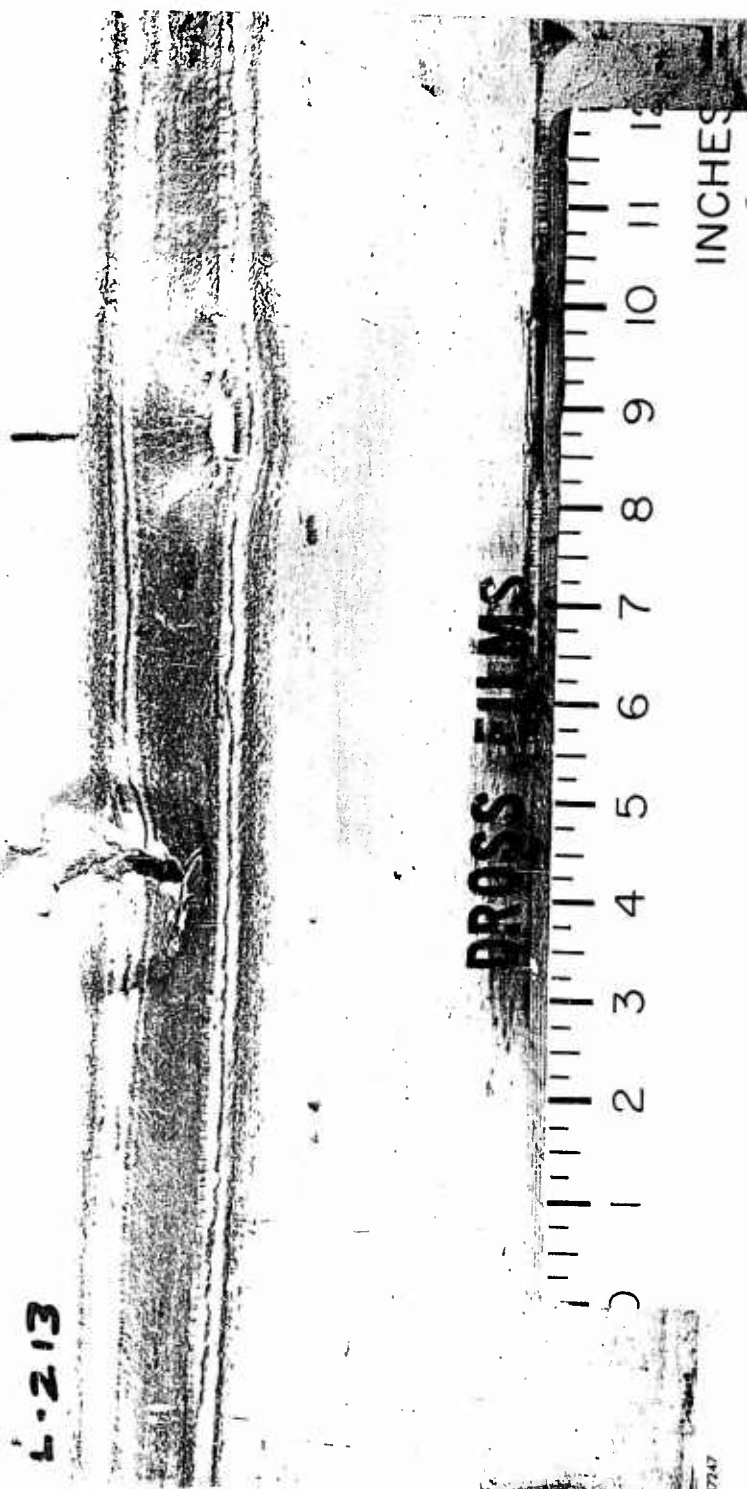
Figure 22

BACK SURFACE OF WELDMENT L213 AFTER BALLISTIC SHOCK TEST
This weldment contained severe dross films

longitudinal defect consisted of a large area, as in the weldment containing large dross films, the strength of the remaining sound metal was insufficient to prevent severe cracking upon ballistic shock.
